# Manhole Inspection Summary

Manhole # S05AA2039MH

**Location** Address: **6002 WESTERN RUN DR**

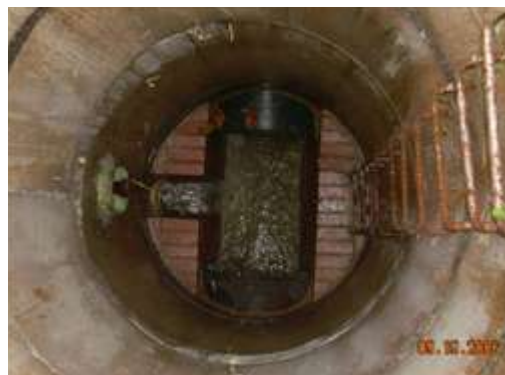
Top View

Infiltration: ☐ None ☒ **Joint** ☐ Cracks ☐ Mortar ☐ Roots ☐ Wall

Infiltration: ☐ None ☒ **Joint** ☐ Cracks ☐ Mortar ☐ Roots ☒ **Wall**

Corbel and Barre infiltration.

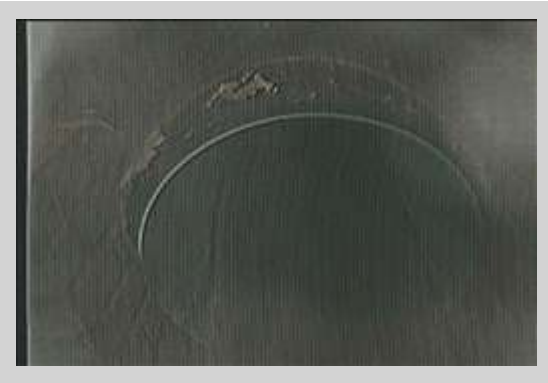
### 27 in. Circular Gravity Sewer Pipe Out @ 12 O'Clock

Infiltration: **None** Pipe Seal Cond: **Unknown**

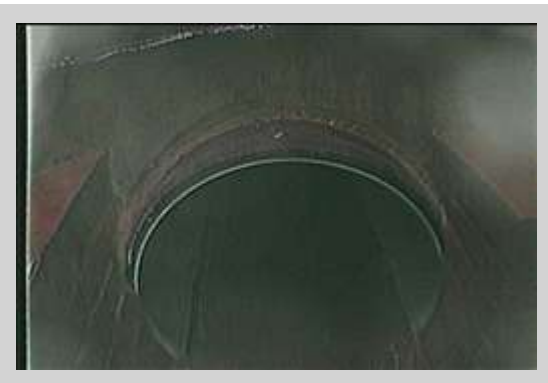
### 24 in. Circular Gravity Sewer Pipe In @ 6 O'Clock

Infiltration: **None** Pipe Seal Cond: **Unknown**

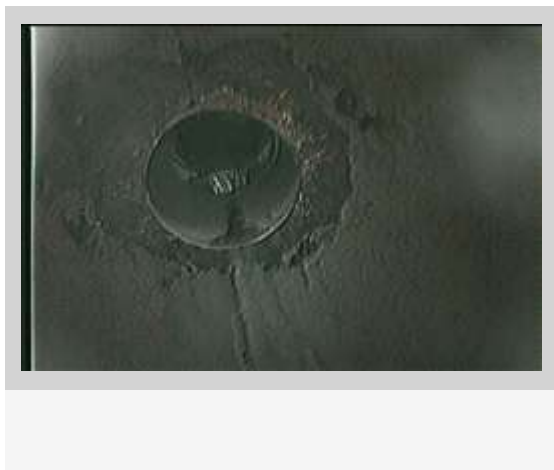
Pipe In @ 9 O'Clock

Infiltration: **Evidence**

Pipe Seal Cond: **Cracked**

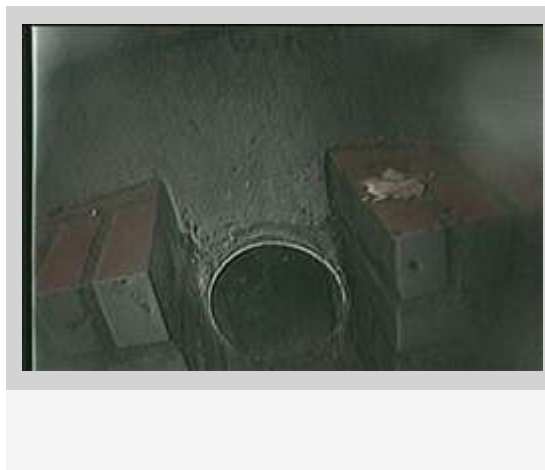
Drop In @ 9 O'Clock

Drop Condition: **Open**
